Demonstration of the Structural Resiliency of Damaged Sentryglas Laminated Heat Strengthened Glass Fins in Full Scale Testing

Abstract: A unique structural design was made for the glass façade of the Co-Creation Center building in Delft. The roof is completely carried by the glass fins. The fins are laterally stabilized by being included in the triple glazed façade. To certify the safety of the design full scale tests on the fins were done at Delft University of Technology. Due to a transportation accident the fins were damaged at one end. This allowed an additional study into the effect of this pre-test damage on the residual compressive stresses induced by the tempering. It was found that the residual stresses were not significantly affected by the damage. During the compression tests no cracks developed at the damaged ends. A load of 200 kN, more than double the maximum design load did not produce failure in the prototypes. After intentionally seriously damaging all plies of the fins, the fins could still carry the 200 kN load for 30 min without buckling or other failures being noted. Measurement of the residual stress in the outer plies of the fins after damage showed that suf

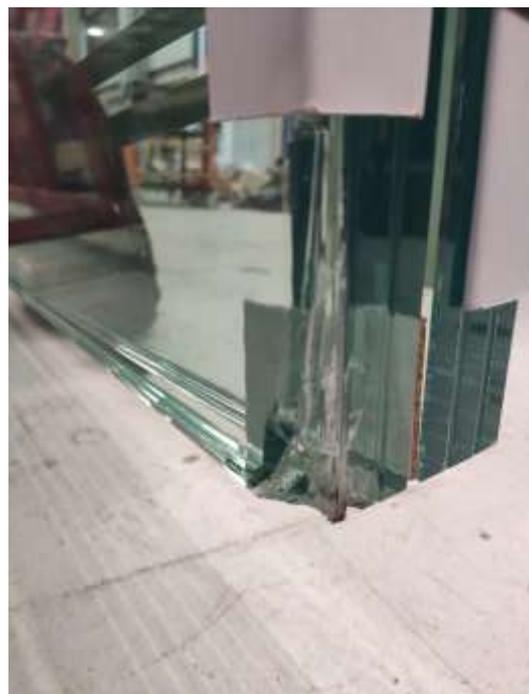
Unfortunately the glass fins were damaged at one end when they were moved into the laboratory by staff not specifically trained to handle glass. The damage is shown in Fig. 4. The damage was measured using a contour gauge as shown in Fig. 5 to determine the depth of the damage. Essentially at the bottom corners of the specimens a triangular bite was taken out of the outer ply over a length of some 24 mm as shown in Fig. 5. This

damage was about half of this some 40 mm up, over a 12 mm length the missing glass tapered from 12 to 6 mm. Above 100 mm from the lower longitudinal edge there was no visible damage. As getting new specimens would take two months and the damaged specimens were assumed to give a conservative test result the damaged specimens were used for testing.

Fig. 4: Transport damage to corner of fin before testing

Scalp measurements of the compressive surface pre-stress at the edge of the damage showed values of -60 ± 15 MPa. This is comparable to the values on the undamaged center line of the specimens. This indicates that the damage should have little effect on the glass strength in this case.

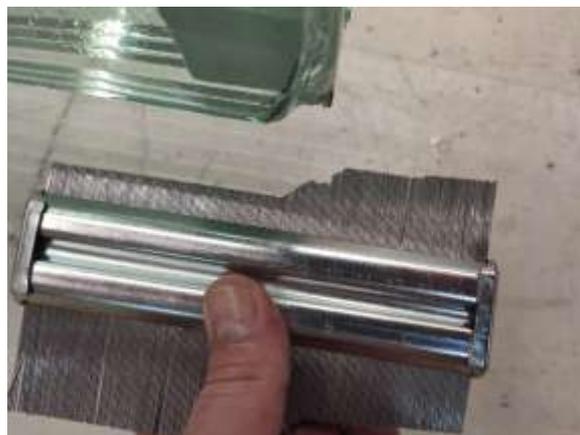
Fig. 5: Measurement of damage using a contour gauge

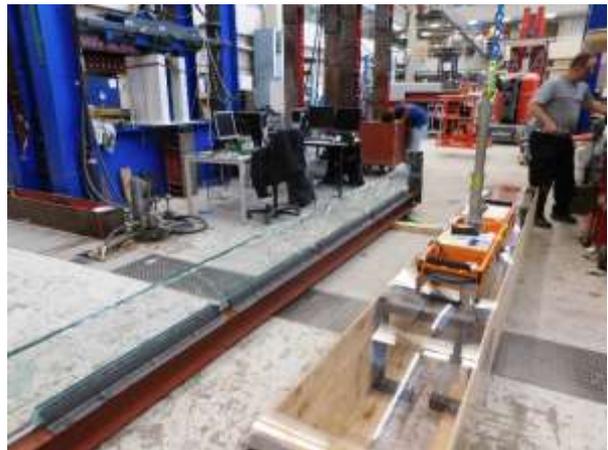
Fig. 6: Damaged specimen siliconed into steel profile which simulates the lateral support of the façade glazing in the real structure

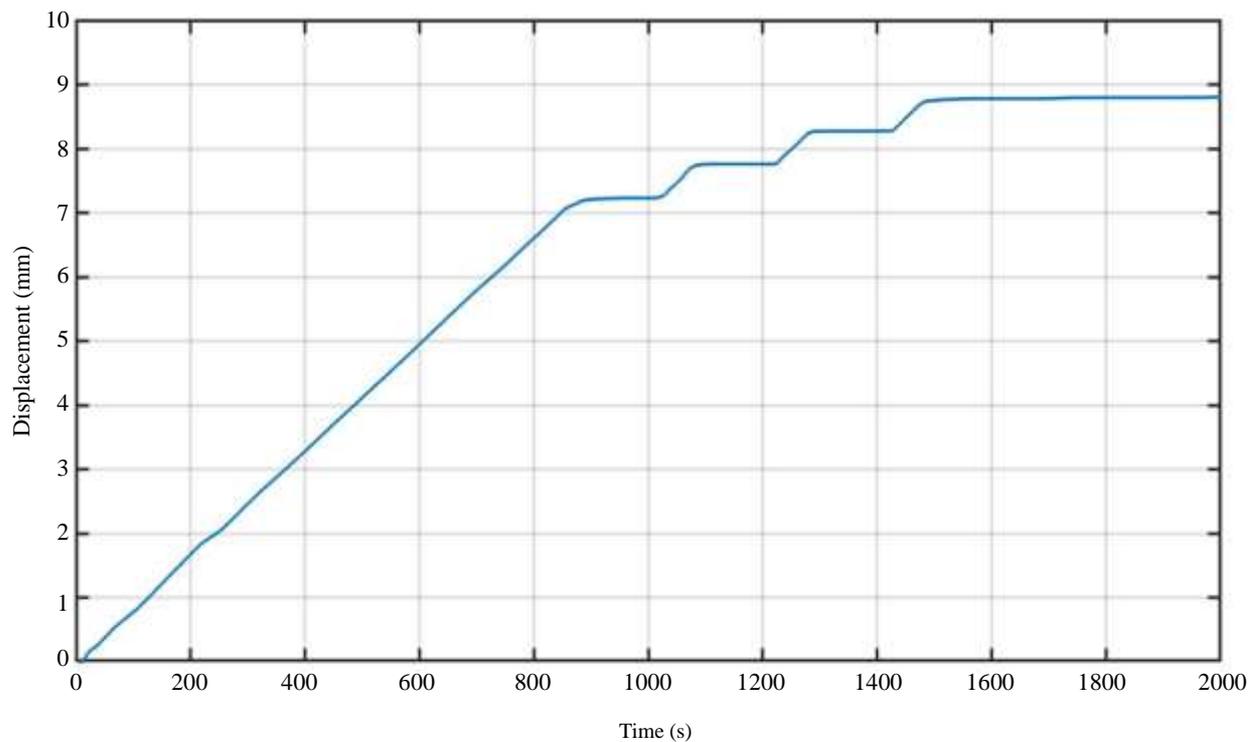
The damage did not result in short term creep, as is shown in Fig. 12, as holding the load constant did not result in additional displacement. Considering the significant levels of damage inflicted on the specimens, as shown in Fig. 13, this result is significant as the interlayer plays a significant role in transmitting forces in damaged specimen.

Fig. 12: Displacement time behaviour of the test on the 2 ply damaged specimen 1

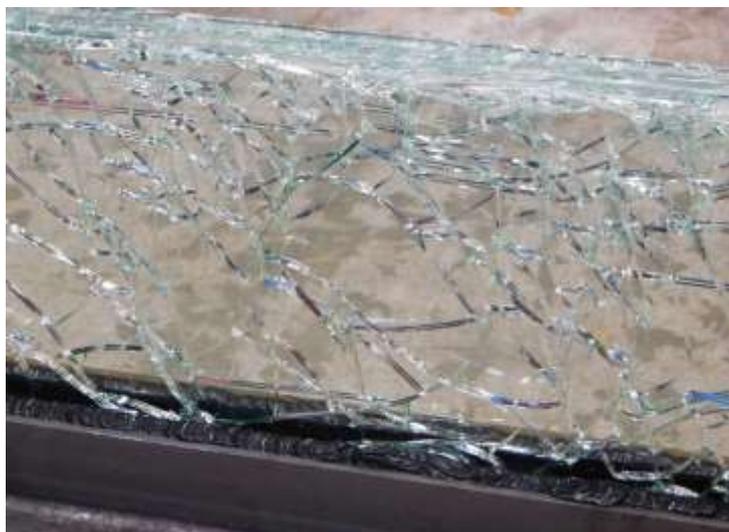
Fig. 13: Part of specimen 2 after having 3 plies damaged. Note the overlapping cracks in successive plies

- The use of heat strengthened glass which breaks into large fragments. These large fragments still maintain a level of compressive surface pre-stress after cracking of the glass and form an overlapping pattern allowing for stress transfer. In essence the cracking of the heat strengthened monolithic fin, turns it into a segmented spliced overlapping fin. As shown by (Trösch, 2015), this can be almost as efficient structurally as monolithic elements with proper lamination
- The use of Sentryglass foil as the laminating agent. The stiffer and stronger Sentryglass foil keeps the glass fragments together very well and the higher stiffness helps prevent buckling
