Technical Reports

# Small Hard Body Impact on Annealed, Heat Strengthened and Fully Tempered Laminated Glass

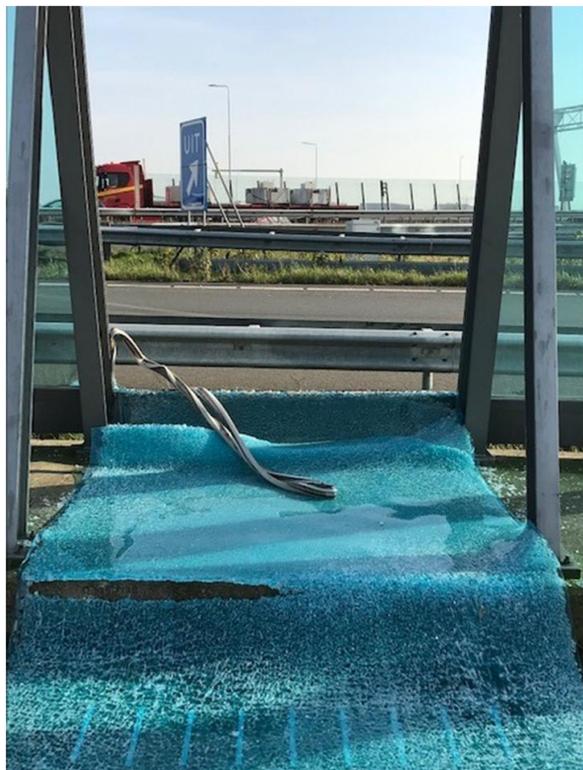
**Fig. 1:** Failed tempered laminated glass sound screen panel

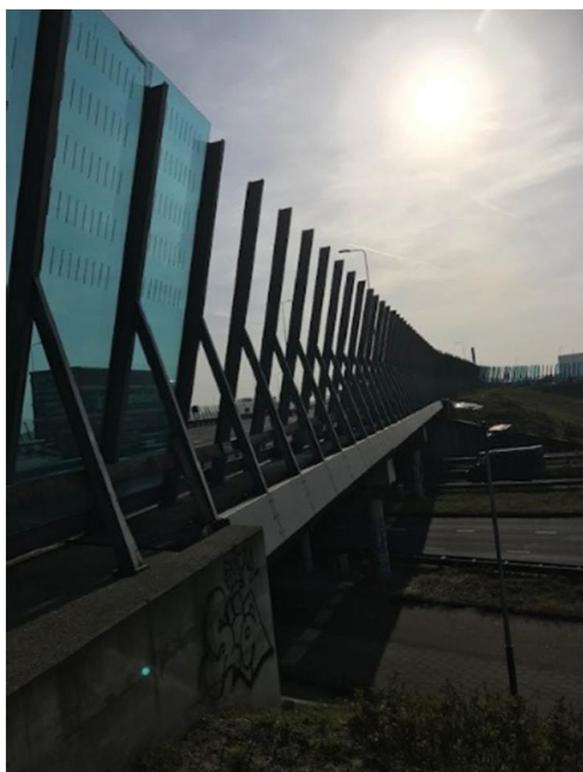
Impacts on architectural glass are infrequent and only the single case of a stone launched by a snow blower hitting a fully tempered laminated glass panel of the apple cube in New York, (Quirk, 2021), is in the open literature. In the field of car windows and glass sound screens impact problems are however a real concern. Figure 1 shows an actual example of a fully tempered laminated glass sound screen panel after both glass plies failed. In certain cases, such as shown in Fig. 2, where a glass sound screen leans over a by-pass, safety concerns can lead to immediate removal of damaged glass.

**Fig. 2:** Sound screen panels leaning over a by-pass removed after safety concerns

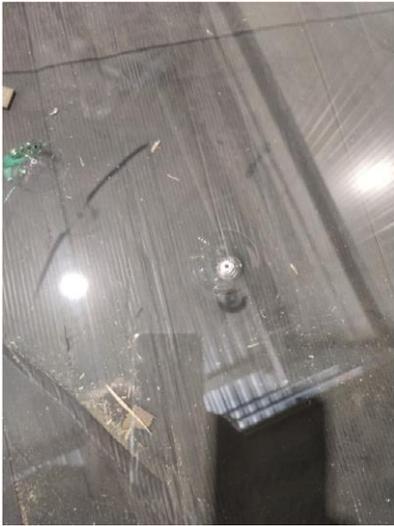
The results are given in Table 3. In annealed glass small hard body impact has no visible effect. Impacting spherical impactors of 14 or 15 mm diameter caused a cone crack, similar to those described by Chaudhri (1989; 2015). Larger impactors cause larger cone cracks, shown in Fig. 5. Cracking from the cone crack region is not caused by the actual impact. Cracks grow from the cone crack zone later due to stress fields from later impacts close to the original damage zone.

**Fig. 5:** Cone crack in the annealed glass after critical impact

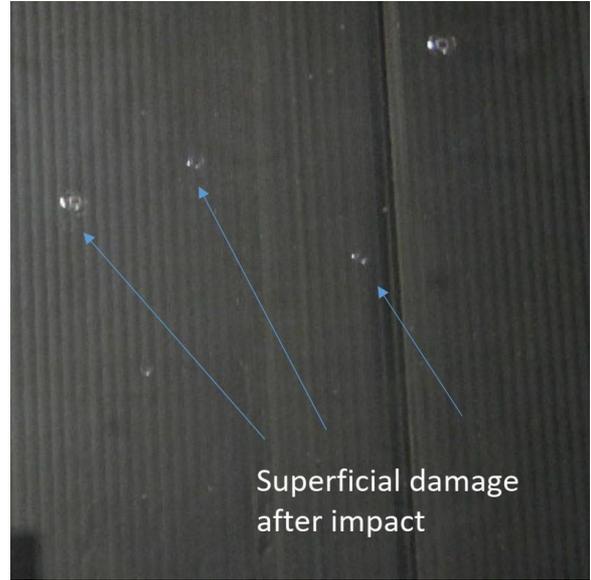
In fully tempered glass with sub-critical impactors slight chipping of the surface, as shown in Fig. 8 is observed. This is not noticeable in annealed and heat-strengthened glass. Larger impactors of 20 mm diameter or more cause total failure of the top layer. An example is shown in Fig. 9. Additional impact of a 25 mm diameter spherical impactors caused failure of the bottom plate also in some cases, leading to total structural failure of the fully tempered panel, as shown in Fig. 10.

**Fig. 8:** Superficial damage to fully tempered glass by non-critical impacts

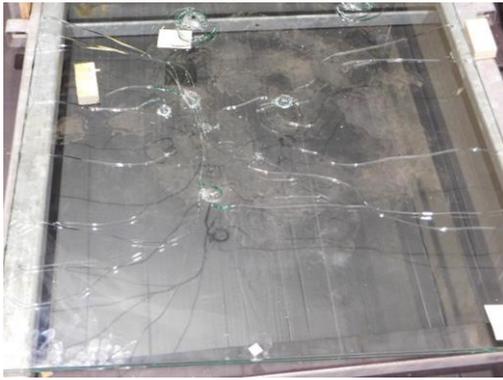
In heat-strengthened glass, the impact of a 16 to 18 mm diameter spherical impactor causes a cone crack with immediate cracking extending from it as shown in Fig. 6. Additional impacts by larger impactors cause more damage. In most specimens after 3 or 4 large cracks have been made, larger impactors do not cause extra damage, presumably as the decreased stiffness reduced the impact stress. One specimen was turned upside down after testing, with the back face being tested also. This specimen could, even after multiple impacts on both sides, still carry a large static load safely as is shown in Fig. 7. As shown by Veer *et al.* (2021), heat-strengthened glass retains at significant fraction of its residual surface compressive strength after fracture, so this is not surprising.

**Fig. 6:** Cone cracks with cracks extending from them in the heat-strengthened glass after multiple impacts

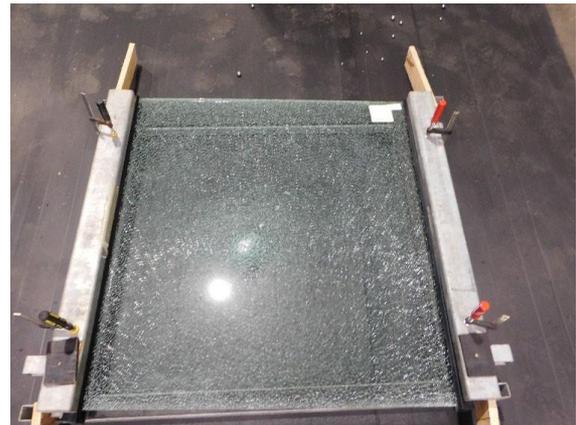
**Fig. 9:** Disintegrated fully tempered glass top-layer

Looking at the  $1 \times 1$  m specimens the results show that fully tempered glass is the most resistant to impact damage. However, if the threshold for impact damage is exceeded the pane completely disintegrates. The tests however also show that a large impact on the fragmented pane can still cause the back pane to fragment also. In that case, as is clear from Fig. 9, there is no residual safety and the damaged panel will not be retained within its frame.

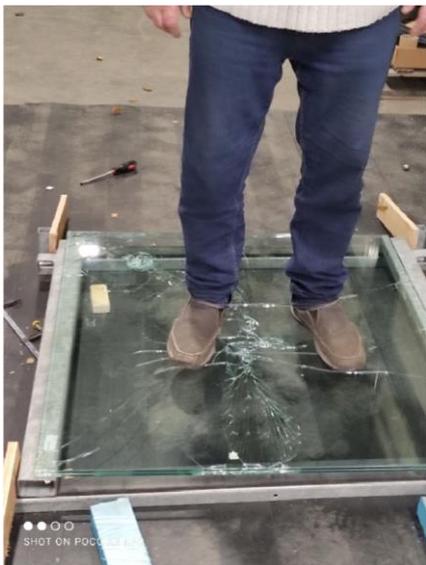
**Fig. 7:** Demonstration of the residual stability of heat-strengthened panel after multiple impacts on both sides

The heat-strengthened glass is demonstrably the most safe. Impact with an energy above the threshold for impact damage causes a cone crack to form which immediately cracks further, presumably due to the tensile stress in the middle of the glass. However multiple impacts, even on both sides, do not impair the safety as the damaged panel can still sustain a significant load as Fig. 10 shows.

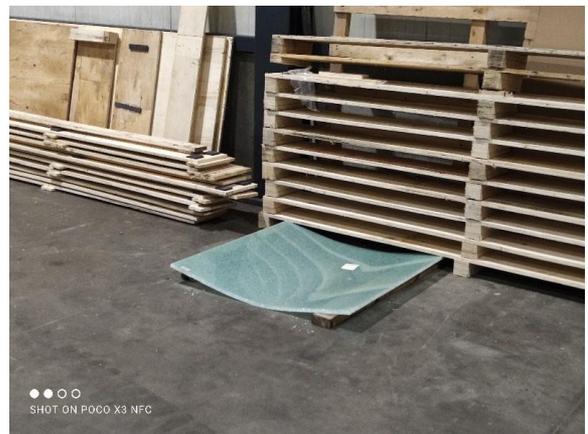
**Fig. 10:** Loss of structural integrity of fully tempered panel after additional impacts caused the failure of the bottom layer

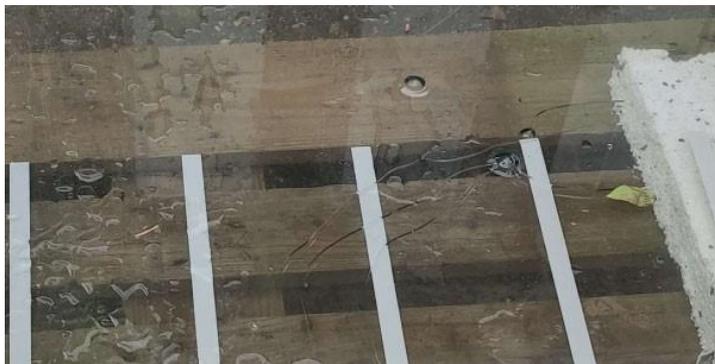
**Fig. 11:** Results of tests on location 1

Tests were done at 6 different locations of the panel, varying in support and aiming at the middle or edge of the panel. The results are described for each location in Table 4 and Fig. 11, 12 and 13 show the impact damage.
