# Tests of Glass Insulating Panels with Embedded Laminated Point Connections

Michaela Zdražilová, Zdeněk Sokol and Martina Eliášová

Department of Steel and Timber Structures, Faculty of Civil Engineering,  
Czech Technical University in Prague, Prague, Czech Republic

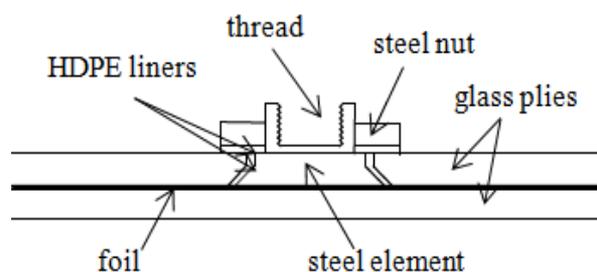
**Fig. 1:** A detail of an embedded laminated point connection used in the experiment

Three sets of equally sized insulating glass panels were provided for the experiment. The length and the width of each specimen were 1500 mm. There was one embedded steel element in each corner of the specimen (four in total). The direct contact between the glass ply and the steel element was prevented by two HDPE (high density polyethylene) liners (Fig. 1). All specimens included two different glass layers. There was a warm edge type plastic spacer (TGI-W 15) placed between the layers; and the whole panel was sealed with polyurethane (Fig. 2).

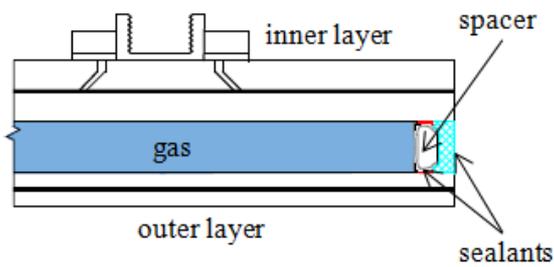
**Fig. 2:** A detail of an insulating glass panel

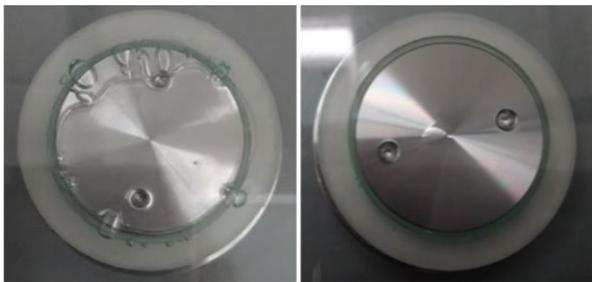
**Fig. 3:** Examples of manufacturing defects (bubbles) located in the area of a connection

Before the experiment, all the specimens were checked in order to reveal manufacturing defects. Majority of specimens included bubbles (Fig. 3) in the area of connections. The bubbles should not affect the performance of the connection, although they are unacceptable for the aesthetical reasons.

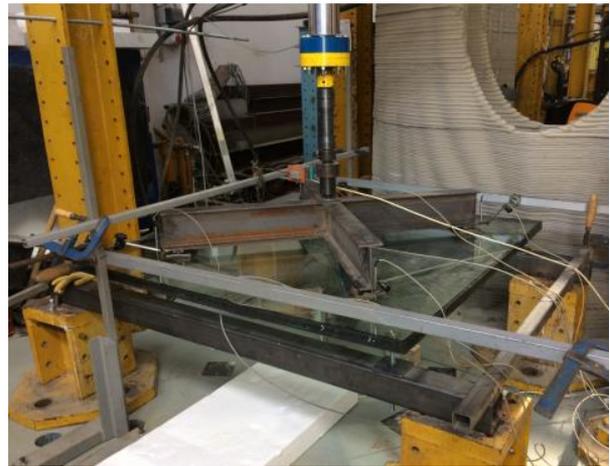
**Fig. 4:** Specimens were placed horizontally and the load was distributed by an X-shaped steel grid

Each set (I, II, III) used for the short-term tests included two specimens. During the experiment, the specimens were placed horizontally and were supported by threatened bars. The load was applied by a single hydraulic jack and it was distributed using a steel X-shaped grid (Fig. 4). The load was applied on the layer without the embedded connections (outer layer). In a real application, that would be the layer facing the wind or a random impact.

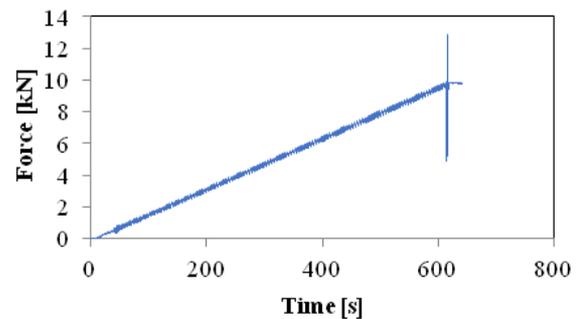
**Fig. 5:** The load was applied at a constant speed of 1 kN/min

The load was applied at a constant speed of 1 kN/min. The load was constantly increasing until the fracture of any part of the glass panel. A shown graph (Fig. 5)

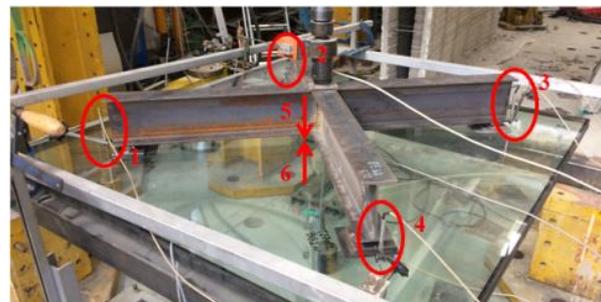
**Fig. 6:** Deflections at six different points were measured

Vertical displacement of the steel grid was monitored during the experiment. Moreover, vertical deflections at four points close to the edge of the steel grid and vertical deflections in the middle of the outer and inner layers were measured. The measured points were situated according to a scheme in the Fig. 6. Stresses in 1-4 points were measured as well. The experiments were performed at a temperature of 25°C.

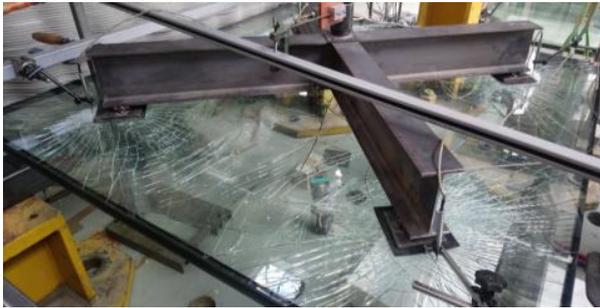
**Fig. 7:** The fracture concentrated in the area of the X-shaped steel grid

Both specimens in the set I were loaded until the first fracture of any part of the specimen. Typically, both glass plies of the outer layer fractured nearly at the same time due to reaching the tensile strength limit. The spider-shaped fractures concentrated in the area of the steel grid (Fig. 7 and 8). The inner layer of laminated glass with the embedded point connections remained undamaged. The specimens were capable to withstand a force of 11.3 kN on average.

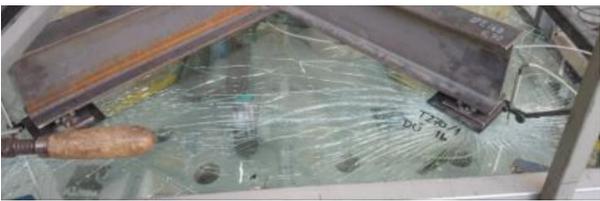
**Fig. 8:** Detail of a spider-shaped fracture

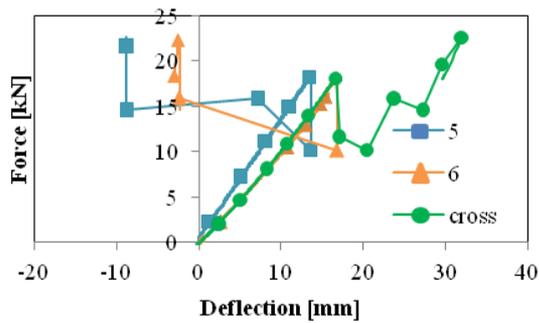
**Fig. 9:** Deflections of a set II specimen at points 5 and 6 and a displacement of the steel cross

The course of the experiment for the set II specimens was basically identical. Both glass plies of the outer layer fractured almost at the same time and the inner layer remained undamaged. However, the value of load was considerably higher, as the specimens were capable to withstand a force of 14.65 kN on average. A graph in the Fig. 9 represents deflections of one of the specimens. Deflections of points 1,2,3,4 correspond to the displacement of the steel cross. Measured deflections of points 5 and 6, copy the trend of the steel cross until the fracture of the outer layer. The course of the deflections of set I and set II is essentially identical due to the float glass outer layer.

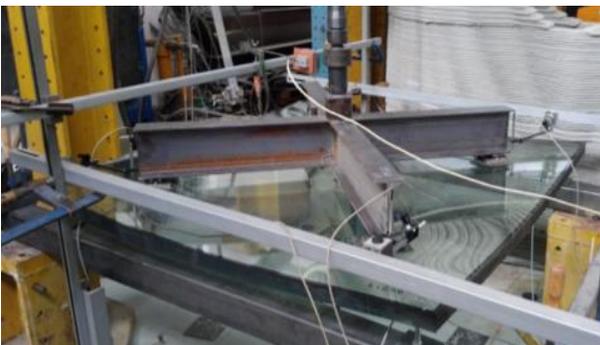
**Fig. 10:** Visible bending of a set III specimen

The first set III specimen was tested in the same way as in the previous cases. The specimen was loaded at a constant speed until the fracture of any part of the specimen. In this case, the drilled ESG glass ply fractured in small, relatively harmless dices typical for this type of glass (Fig. 10). The glass fractured due to reaching the tensile strength limit in the mid-span caused by the bending of the panel (Fig. 11). The other ESG ply remained undamaged as well as the outer ESG ply. After the fracture of the drilled ply, it was possible to pull the point connections out of the specimen. The steel elements debonded from the foil. However, the foil remained undamaged (Fig. 12).

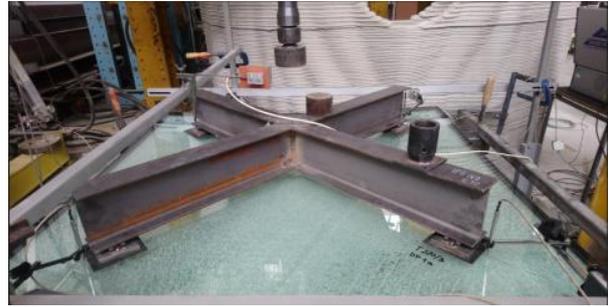
**Fig. 11:** The ESG glass ply fractured in small dices

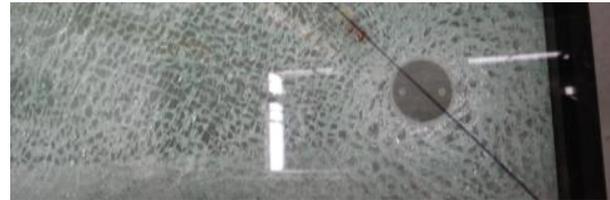
**Fig. 12:** The steel element debonded from the foil but the foil remained undamaged

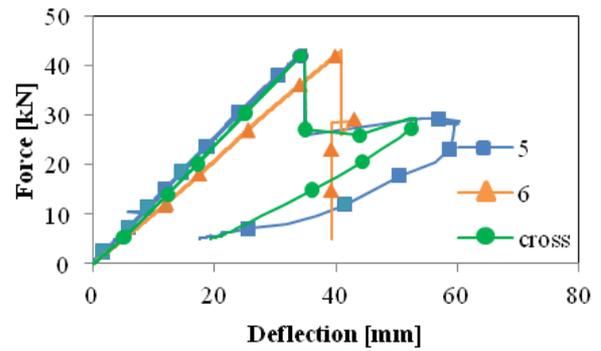
**Fig. 13:** Deflections of a set III specimen at points 5 and 6 and a displacement of the steel cross

The second specimen was also loaded until the fracture of any part of the specimen. Its behavior was identical as in the previous case. The deflections are shown in the graph in the Fig. 13. Deflection of point 5 copies the trend of the steel cross the whole time.

The deflection of the inner layer (point 6) copies the displacement of the steel cross only until the fracture. After the fracture of the inner layer, the specimen was unloaded and loaded again until the complete collapse. The steel elements debonded from the foil but the foil remained undamaged.

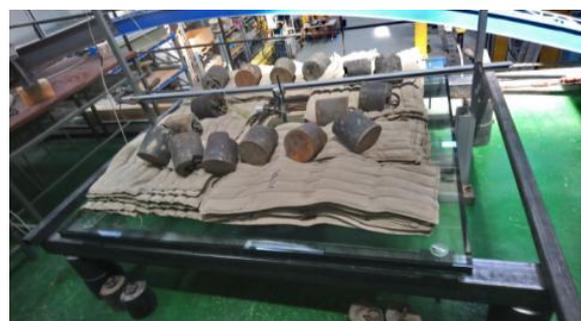
**Fig. 14:** The panel was loaded by a weight of 524 kg and left for 12 days

As a first step, the panel was loaded with the weight of 524 kg and left for 12 days (Fig. 14). After 12 days, the inner layer was found fractured (Fig. 15). The load was increased to 832 kg (Fig. 16) and kept until the complete collapse of the insulating panel. The panel

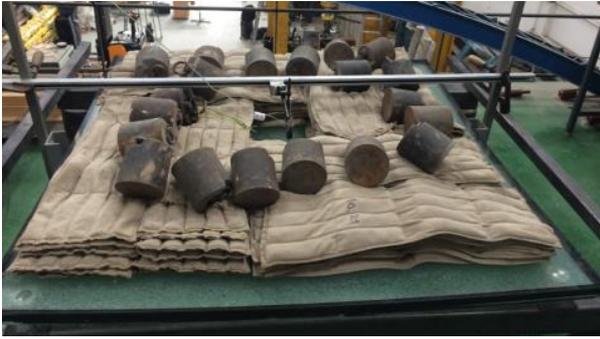
**Fig. 15:** The panel was found fractured after 12 days

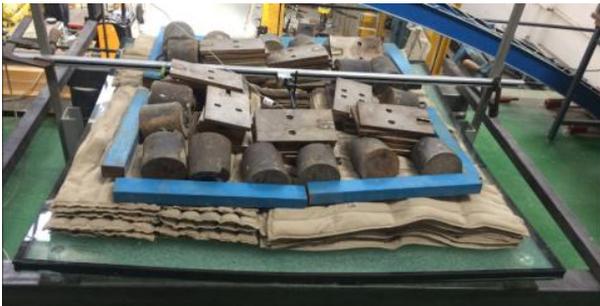
**Fig. 16:** The load was increased to 832 kg

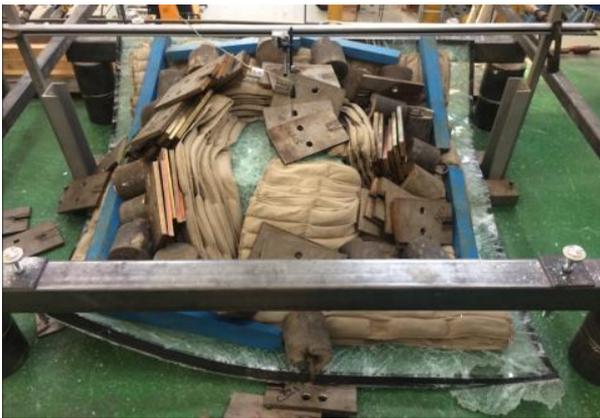
**Fig. 17:** The insulating panel collapsed after 43 days at the load of 832 kg

was found collapsed (Fig. 17) after another 21 days. The experiment took 43 days in total.

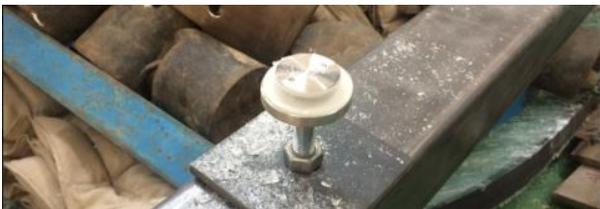
**Fig. 18:** The steel elements along with the threaded bars stayed on the places

After the collapse, the glass panel was pulled out of the steel connecting elements. The steel elements along with the threaded bars stayed on its places (Fig. 18). The foil was not damaged.

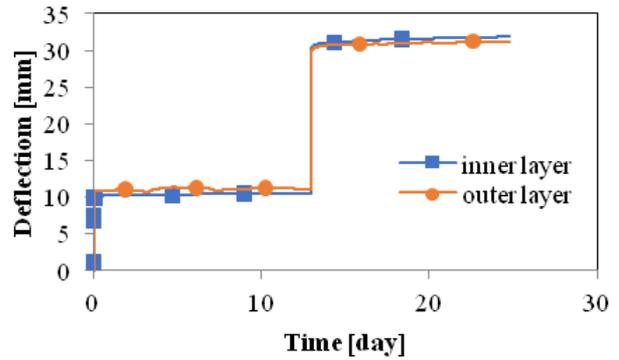
**Fig. 20:** Bending of the layers of the insulating panel

A graph in the Fig. 19 represents the loading scheme of the specimen. The panel was capable to bear the load of 524 kg (3.5 kN/m<sup>2</sup>) for 12 days. The fractured panel showed a promising post-breakage capacity as it was able to bear the load of 832 kg (5.5 kN/m<sup>2</sup>) for 21 days. Bending of the laminated glass layers represents the graph in the Fig. 20. Measured temperature and humidity are shown in the graph in the Fig. 21.

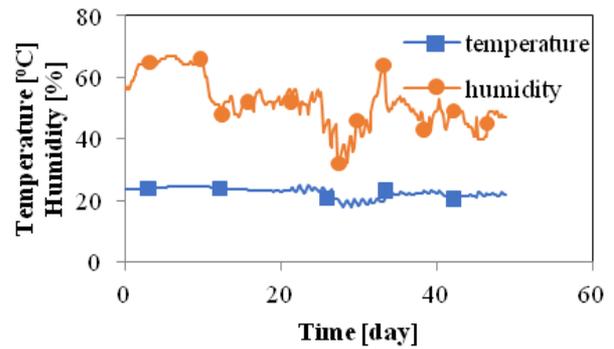
**Fig. 21:** Temperature and humidity were measured during the experiment
