Demonstration of the Structural Resiliency of Damaged Sentryglas Laminated Heat Strengthened Glass Fins in Full Scale Testing

Abstract: A unique structural design was made for the glass façade of the Co-Creation Center building in Delft. The roof is completely carried by the glass fins. The fins are laterally stabilized by being included in the triple glazed façade. To certify the safety of the design full scale tests on the fins were done at Delft University of Technology. Due to a transportation accident the fins were damaged at one end. This allowed an additional study into the effect of this pre-test damage on the residual compressive stresses induced by the tempering. It was found that the residual stresses were not significantly affected by the damage. During the compression tests no cracks developed at the damaged ends. A load of 200 kN, more than double the maximum design load did not produce failure in the prototypes. After intentionally seriously damaging all plies of the fins, the fins could still carry the 200 kN load for 30 min without buckling or other failures being noted. Measurement of the residual stress in the outer plies of the fins after damage showed that suf

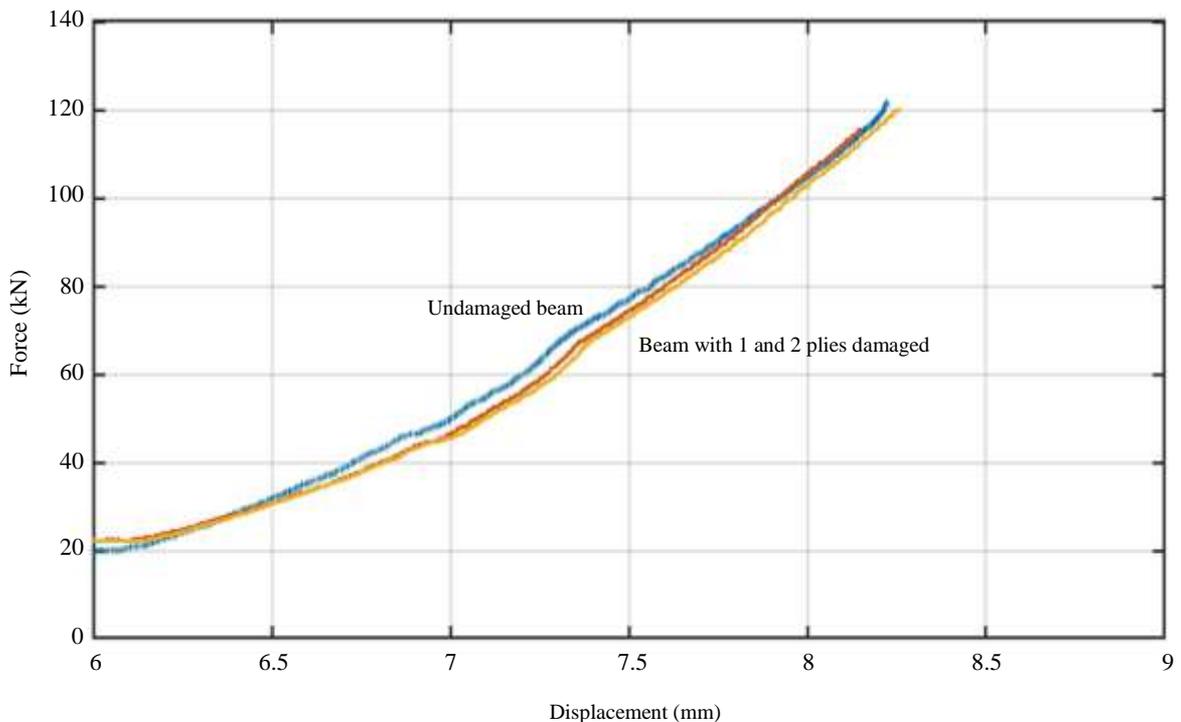
Fig. 10: Load displacement behaviour of specimen 1

There was no failure of the glass fin under loading. Both the undamaged and damaged specimens were capable of dealing with a load at least double the maximum load expected in service. Figure 10 shows the load/displacement behaviour of the tests on specimen 1. Figure 11 shows the load displacement behaviour of specimen 2. The initial non-linearity of the load displacement curves in Fig. 10 and 11 is the result of movement in the steel top connection, which requires some displacement before the load is fully
