Technical Reports

# Small Hard Body Impact on Annealed, Heat Strengthened and Fully Tempered Laminated Glass

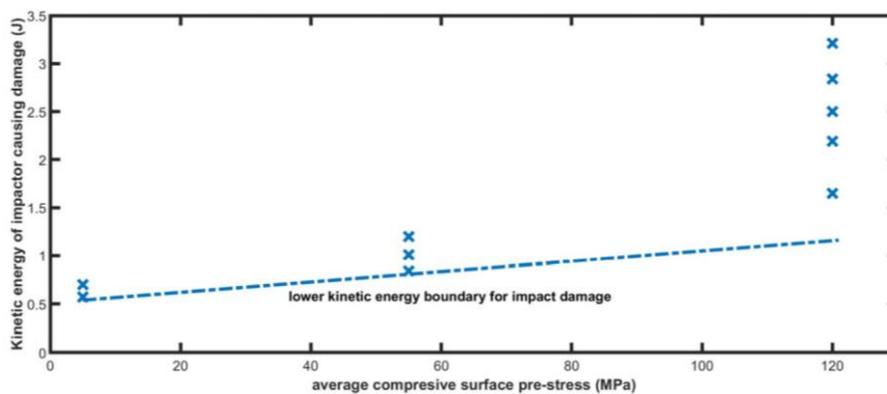
**Fig. 14:** Relation between average pre-stress and critical energy for impact damage

Figure 14 shows a plot of pre-stress against impact energy causing damage for all tests, with a lower and upper boundary. Although the scatter is considerable it is clear that higher surface compression pre-stress causes a significant increase in the critical kinetic energy to cause impact damage. This however is outweighed for practical purposes by the lack of residual strength caused by the total fragmentation of fully tempered glass.
